PILC OPERATING EXPERIENCES & PRACTICES

STAN HEYER
PECO ENERGY CO.
APRIL 30, 2003

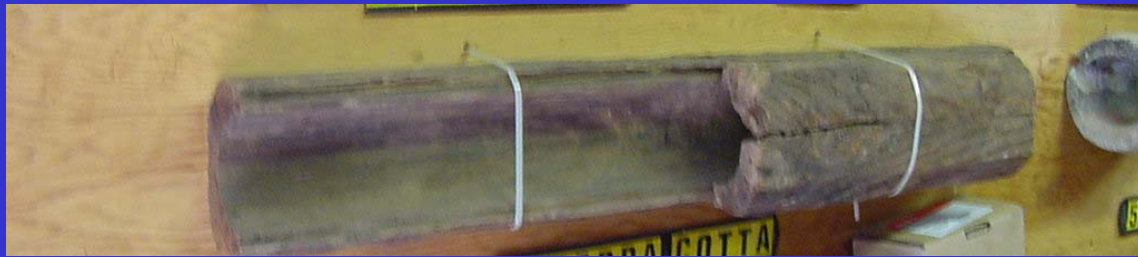
Wooden Duct

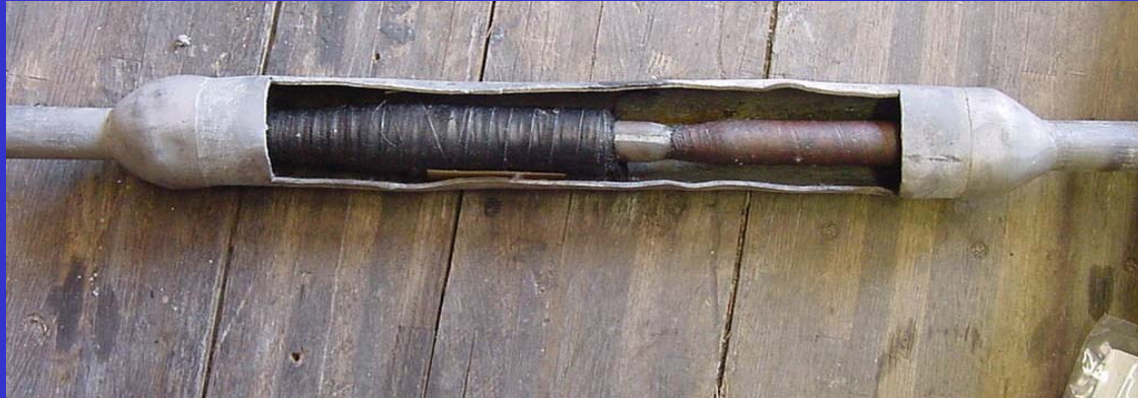
Single Phase Splice

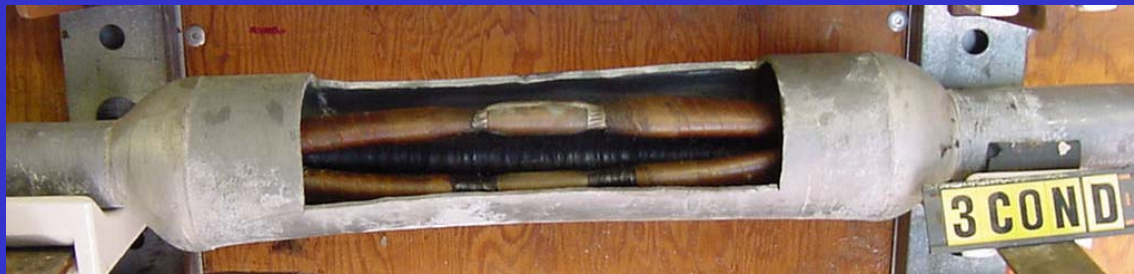
3 Phase Splice

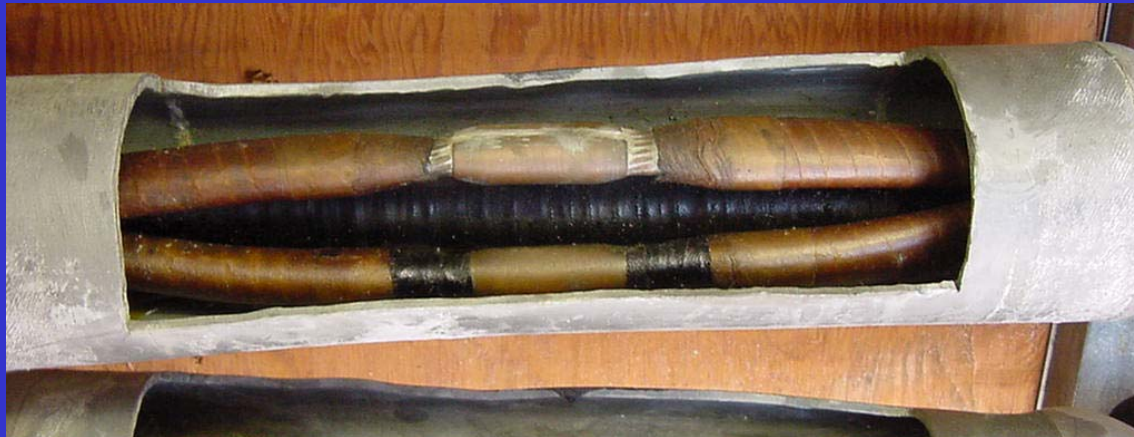
Close Up 3 Phase Splice

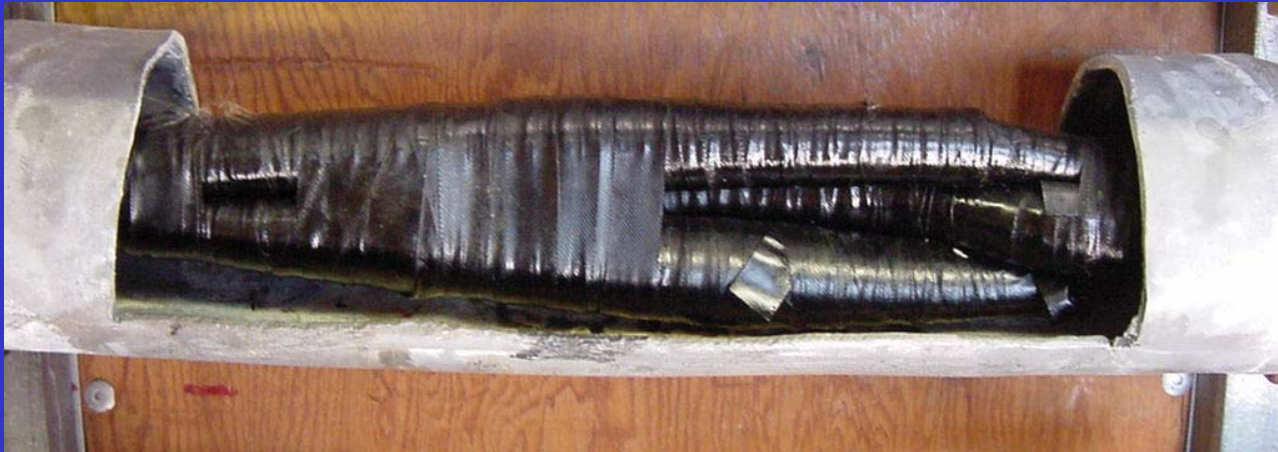
Completed Insulated 3 Phase Splice

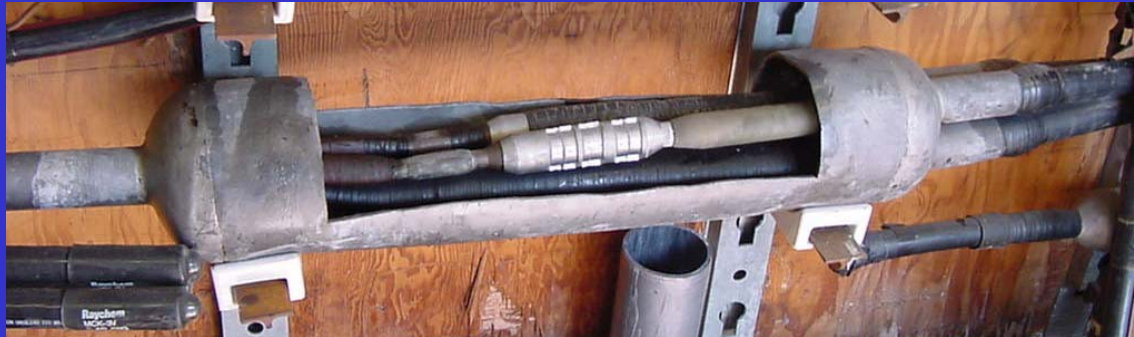
Four Way Splice

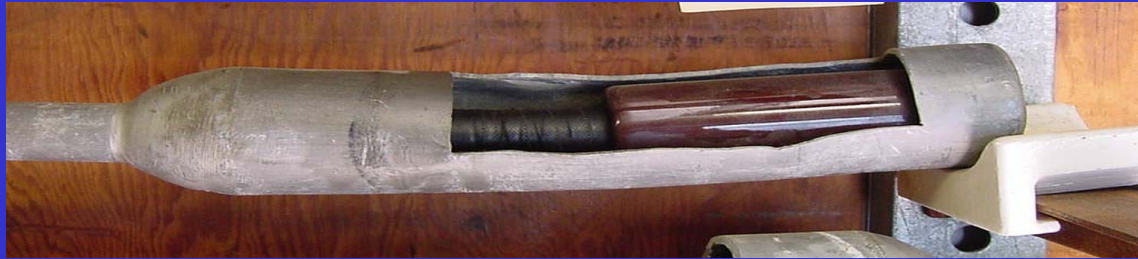
Single Phase Live End Seal

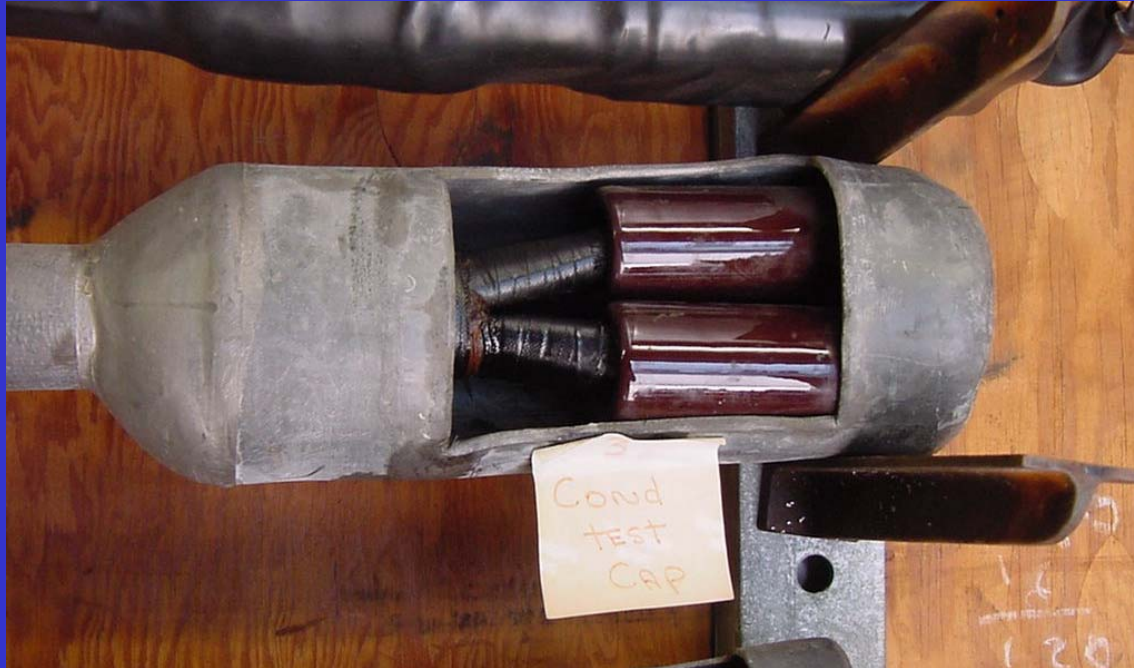
3 Phase Test Cap

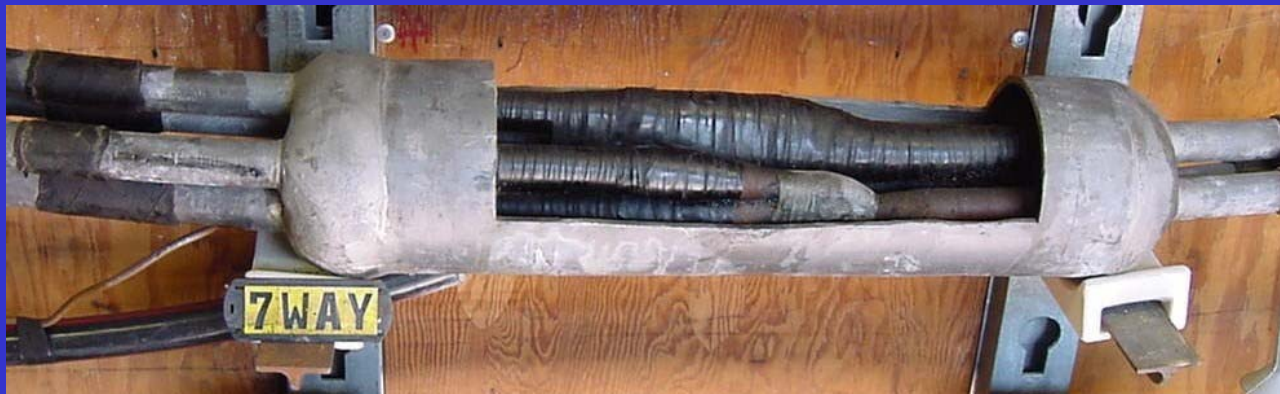
Seven Way Splice

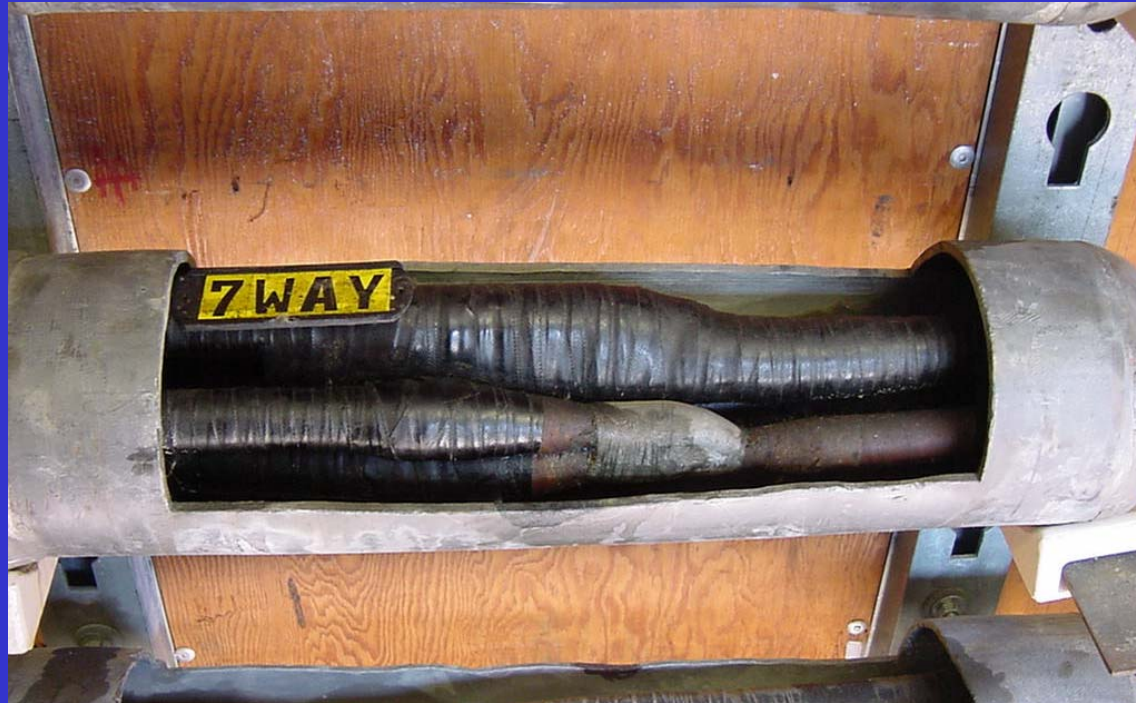
Close up of 7 Way Splice
