HISTORY OF RUGGEDIZED URD CABLE DEVELOPMENT

Kyle E. Cope

Pirelli Cables & Systems North America

ICC Educational Program, April 20, 2005

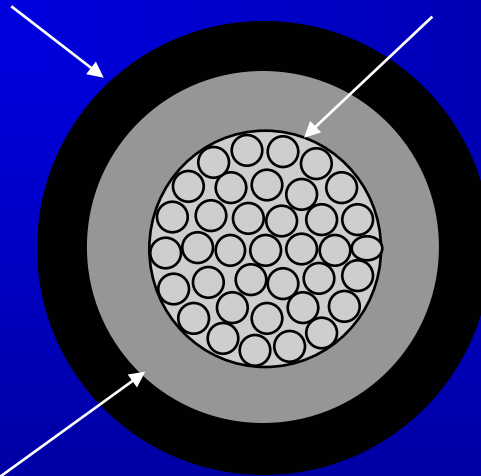
Dual Layer/Single Layer Design

Polyolefin Outer Layer

Aluminum Conductor

Polyolefin Inner Layer

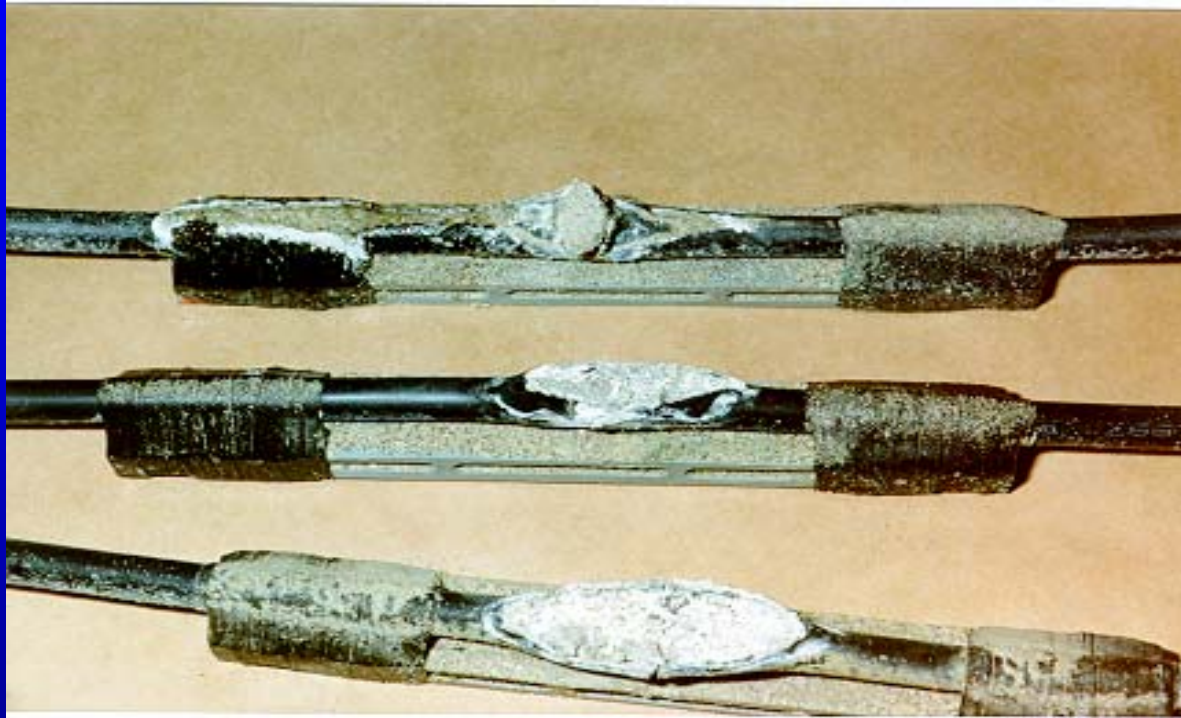
Failed Samples

Cable Failure Mechanism

Mechanical Abuse

Insulation Breakdown

Conductor Corrosion

Increased Leakage Current

Cable Failure

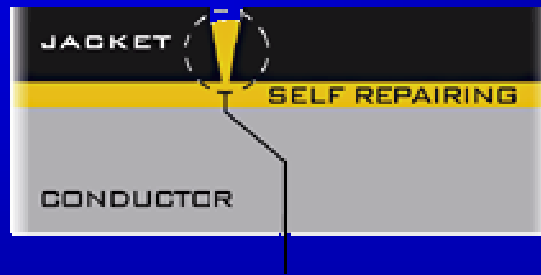
Damage through insulation
to Conductor

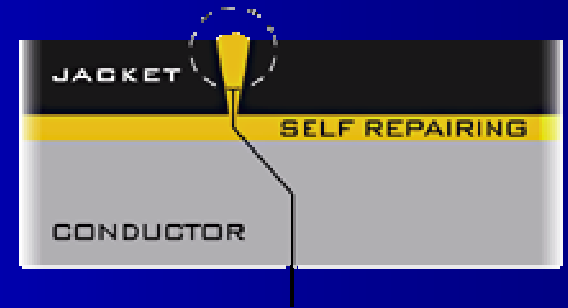
Self Repairing Starts

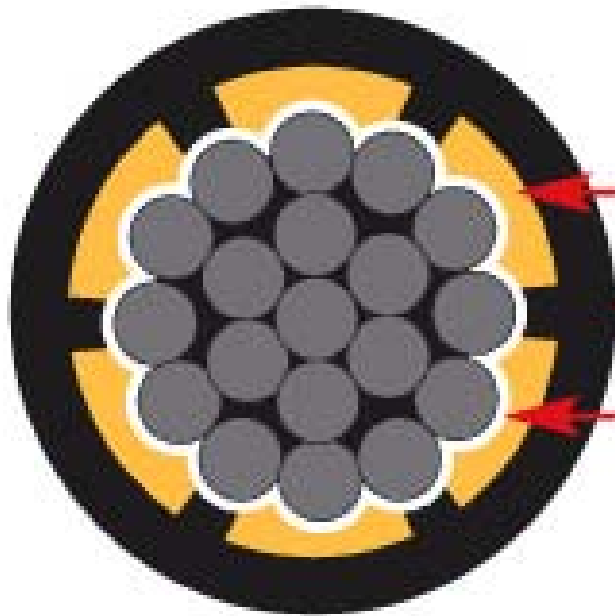
Self-Repair Construction

Self-Repairing Compound

High Density XL Polyethylene

Mylar Separator Tape

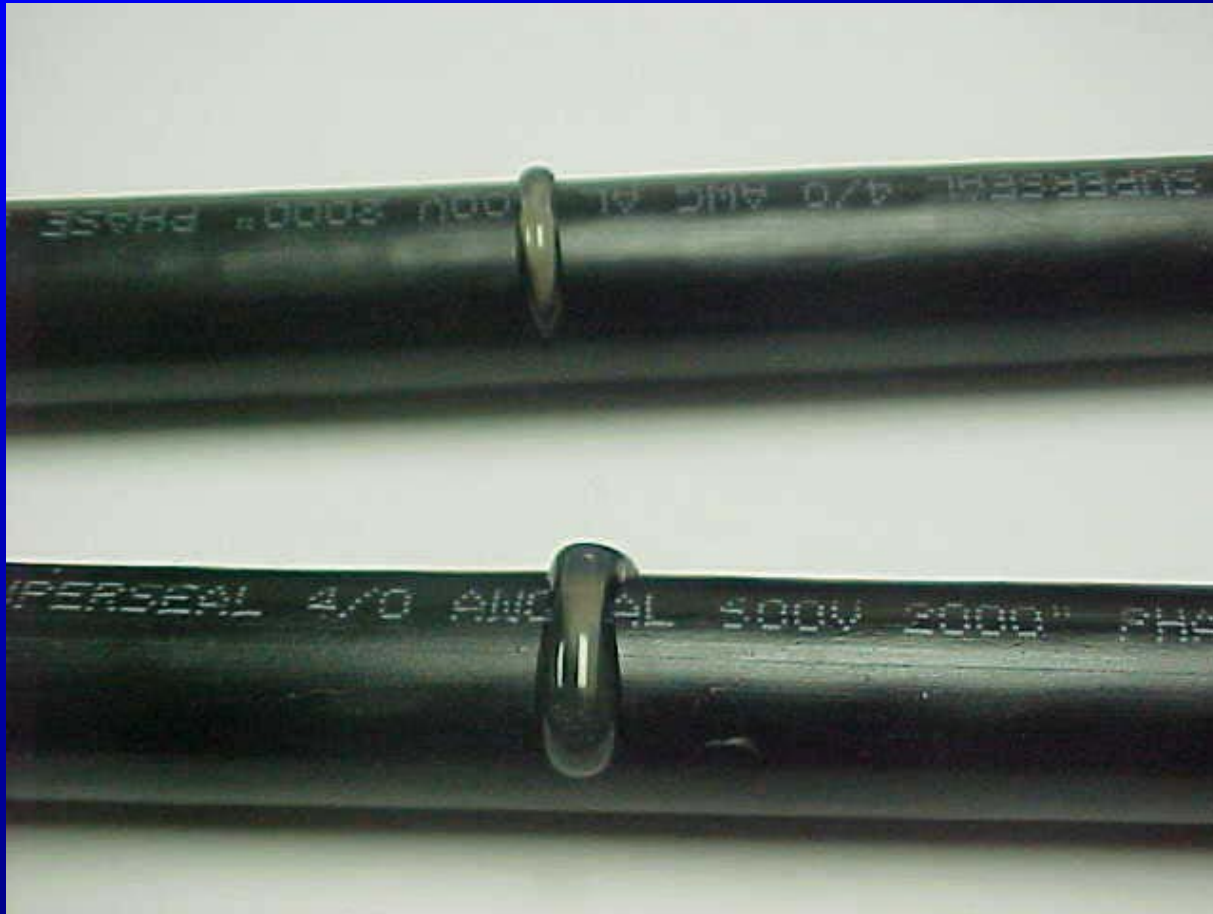
Self-Repair Design After Damage

- A dielectric material
- Highly cohesive
- Excellent cold flow behavior
- Flow stops when cut filled in
- Insulation characteristics are restored
