The Impact of Transmission Cable System Construction and Design on Commissioning Test Options & Results

Steve Campbell
General Cable

Benjamin Lanz
IMCORP

ICC Meeting in Fountain Hills, AZ

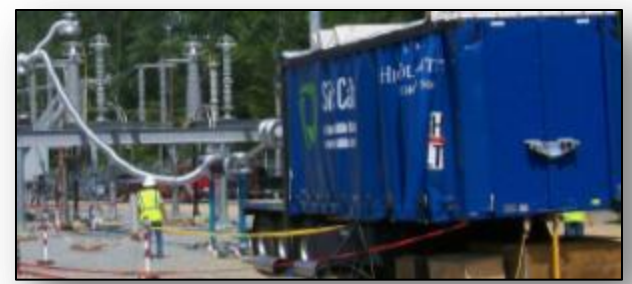
Overview

- 2 recently commissioned 230kV cable systems
- Commissioned using equipment & technologies stationed in the United States
 - 22MVA variable frequency voltage source
 - PD test technology
- Systems have similar component specs.
- Client required 1.7U_o withstand for 60 minutes
- Brief look at how system construction & design impact testing options & results

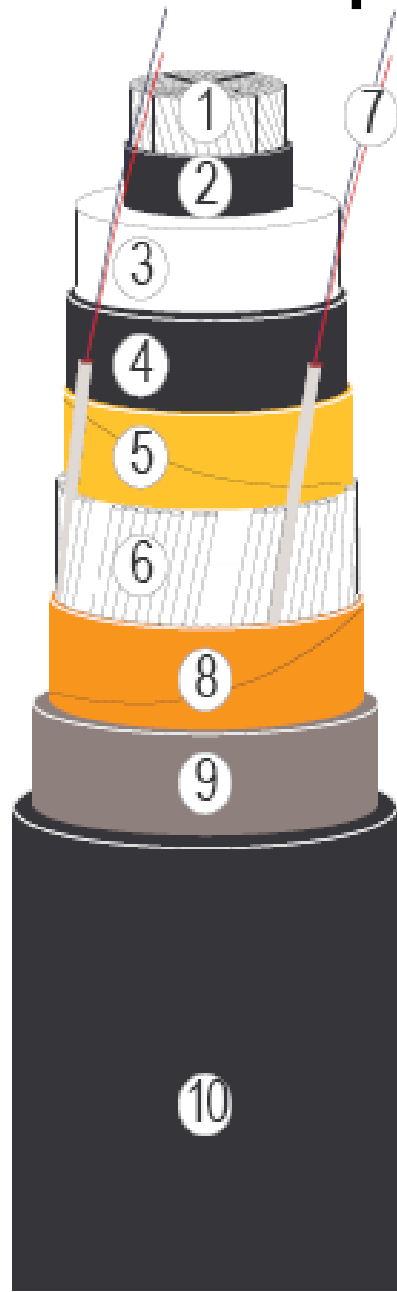
Cable Description

1 - CONDUCTOR

Cross-section : 3500 kcmil, segmental

Material : copper

2 - INNER SEMI-CONDUCTIVE LAYER

3 - INSULATION

Material : cross-linked polyethylene

4 - OUTER SEMI-CONDUCTIVE LAYER

5 - CONDUCTIVE SWELLING BEDDING TAPE

6 - ALUMINUM SHIELD WIRES

41 wires of 84.3 mils each

7 - OPTICAL FIBERS

3 FO cables of 2-50/125 μm multimode fibers embedded in a PE jacket

9 - LONGITUDINALLY APPLIED SMOOTH ALUMINUM TAPE

10 - OUTER SHEATH AND EXTRUDED SEMICONDUCTING LAYER

INDICATIVE EXTERNAL DIAMETER : 4.84 in

INDICATIVE WEIGHT : 16.6 lbs/ft

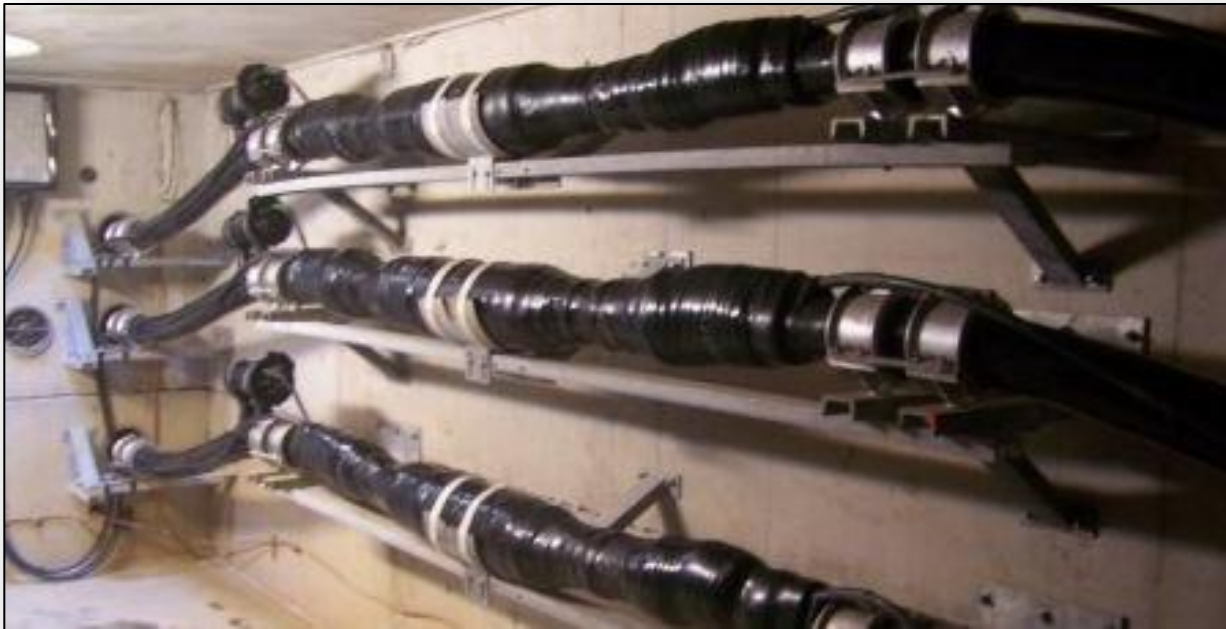
Preliminary Sensitivity Assessment for System A (5.8 miles) con't

- 100pC observable through 4 joints thus HF signal blocker necessary at termination
- Probable test capabilities: detect PD from cable, joint, or termination in a +/- 2000ft segment with ~5-10pC sensitivity

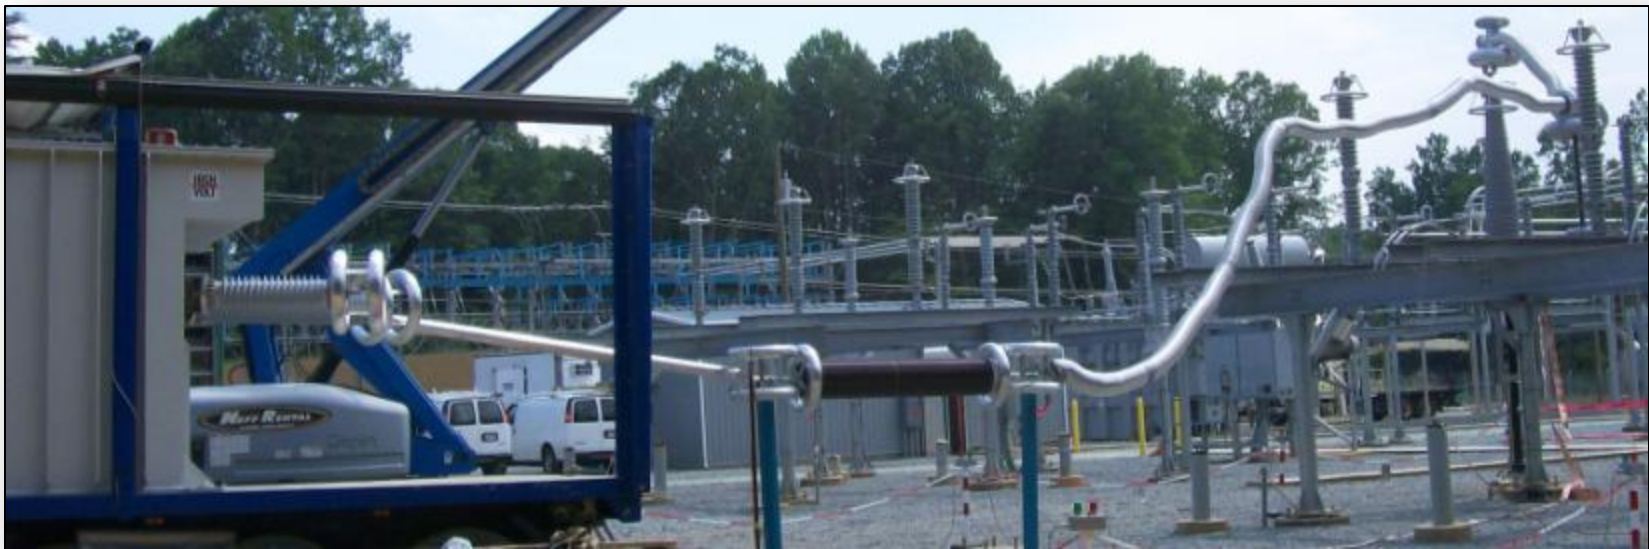
System A Results

- Tests performed with multiple sensors in parallel to accelerate test process
- Voltage applied at nearly $1.7U_0$ for 60 minutes
- All cable systems passed the withstand test
- No PD was detected at any of the joint locations

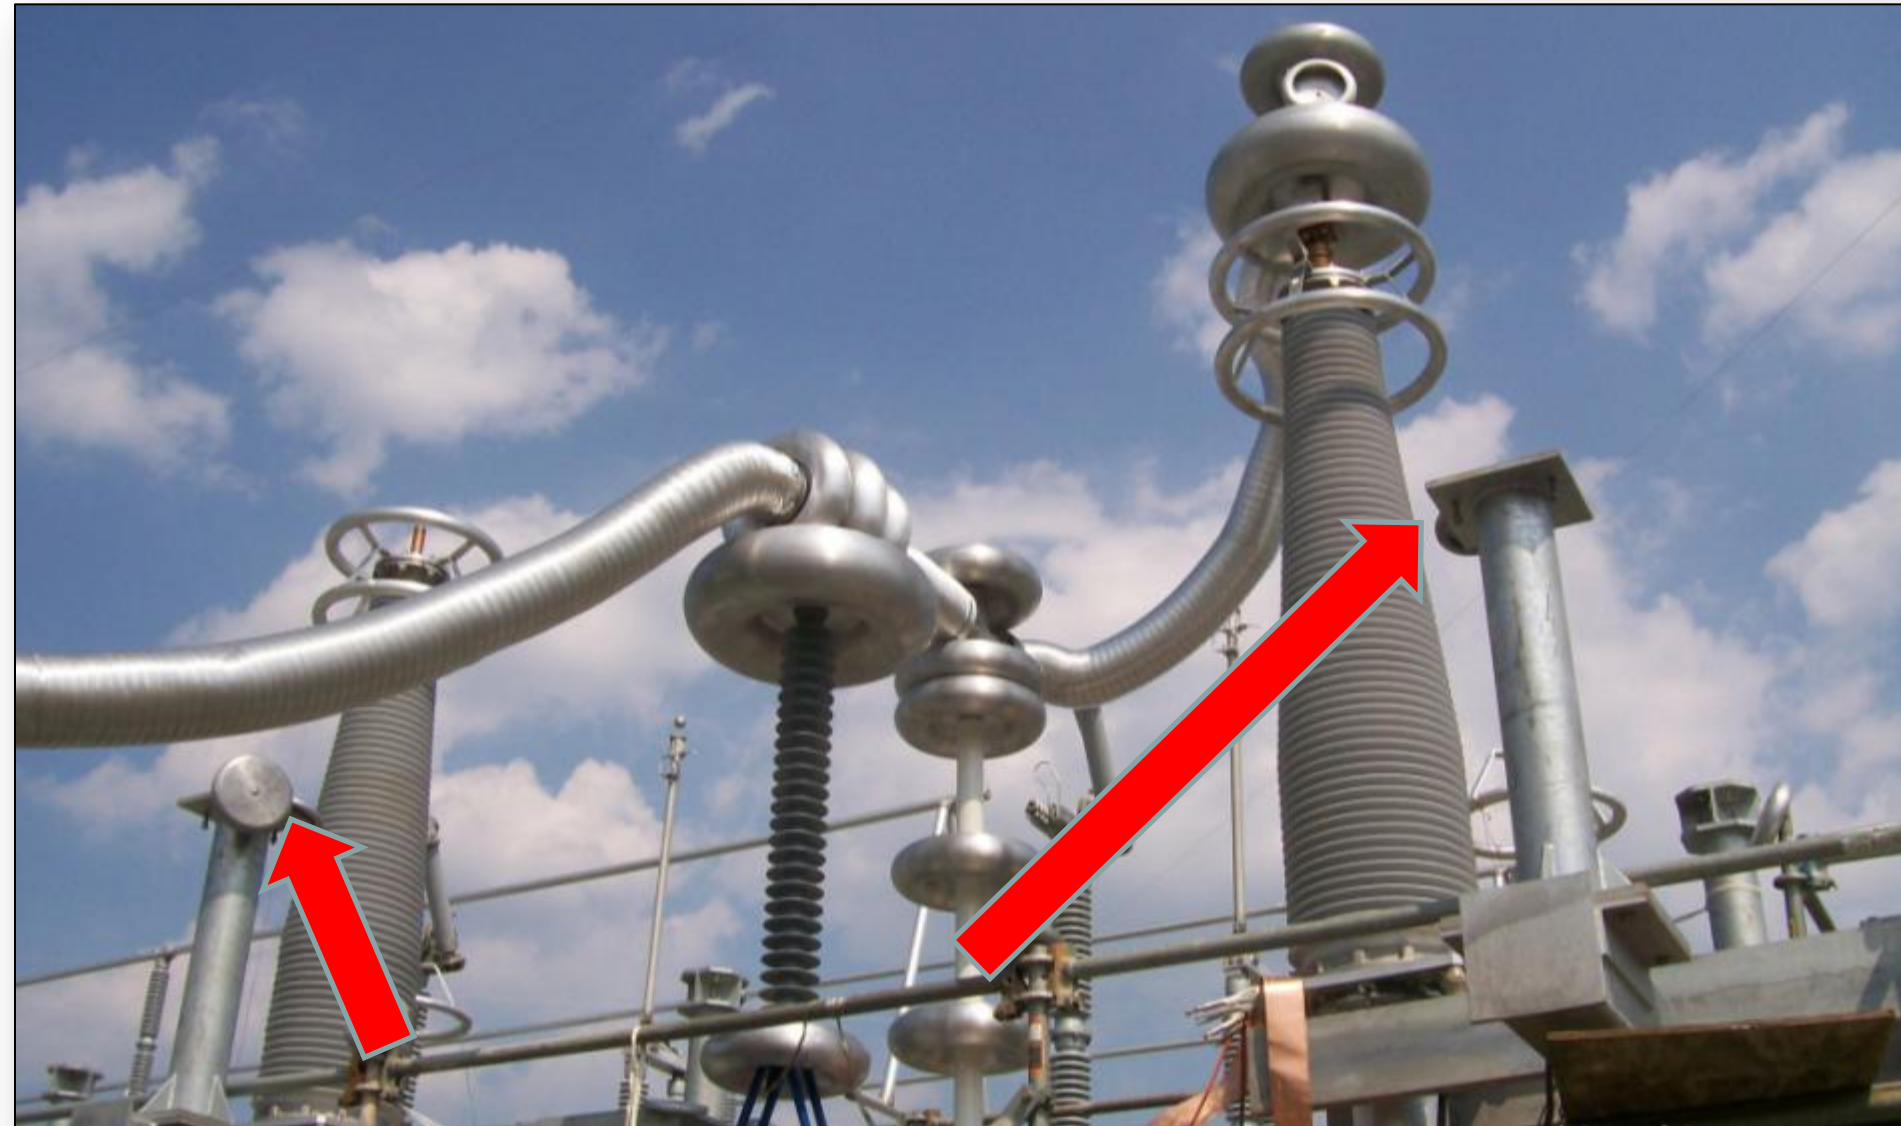
System B Results –corona sources

- Single sensor directly connected to one termination.
<5pC sensitivity achieved
- A & B phases exhibit external corona at the near end terminations at $\sim 1.5U_0$
- Corona rings added on adjacent to equipment with sharp edges to distribute electric stress
- PDIV of external corona goes to $\sim 1.7U_0$
- No other PD sources detected
- A& B phases pass withstand for 60 minutes

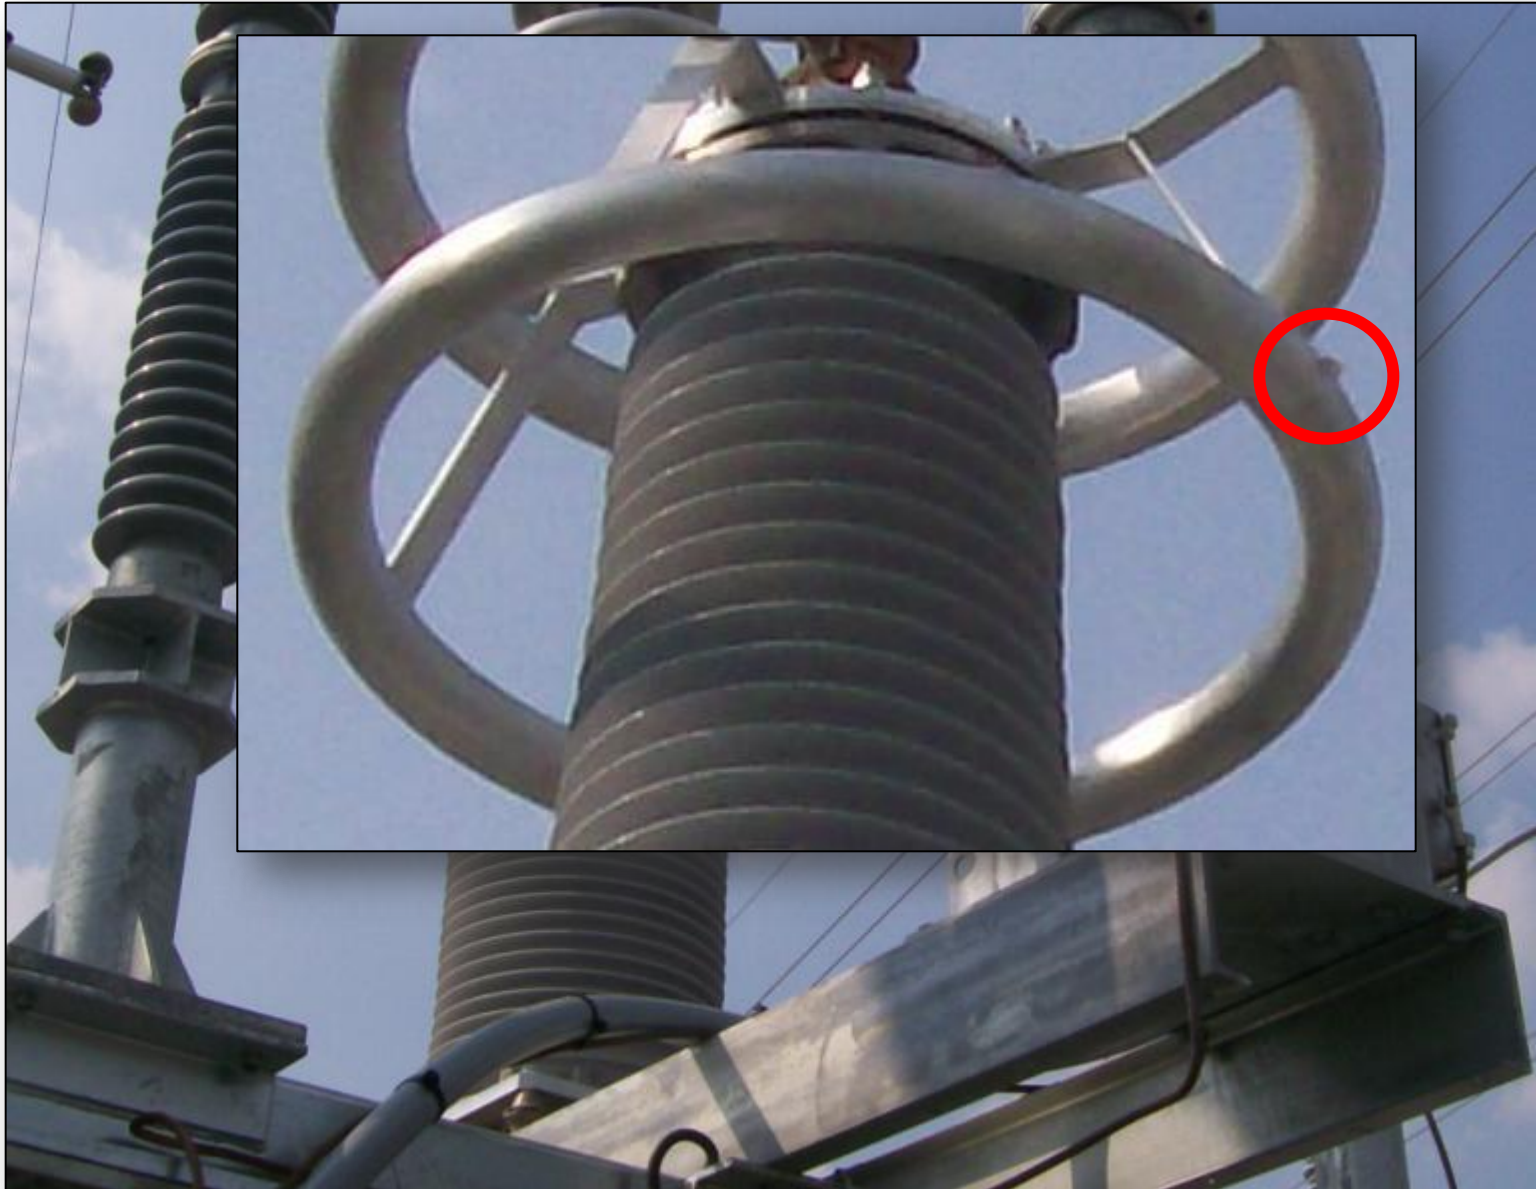
Far End Termination Inspection

- C phase exhibits PDIV $\sim 1U_0$ at far end termination
- PD crew recommends inspection
- Withstand crew continues with $1.7U_0$, 60 minute withstand per cable owner's specification
- Termination did not fail
- Inspection of the far end termination reveals...
